Images shown are of the flooring throughout the building.

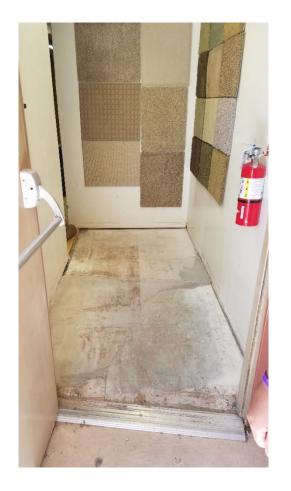
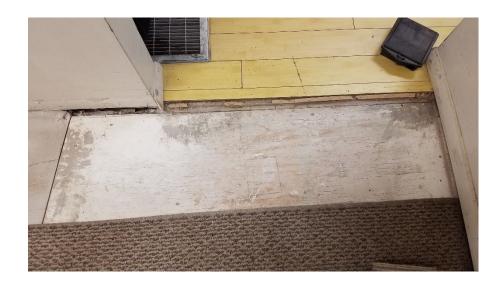
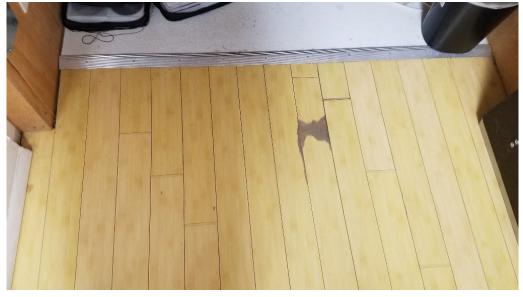
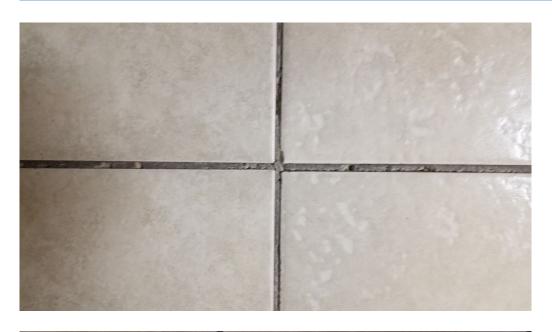
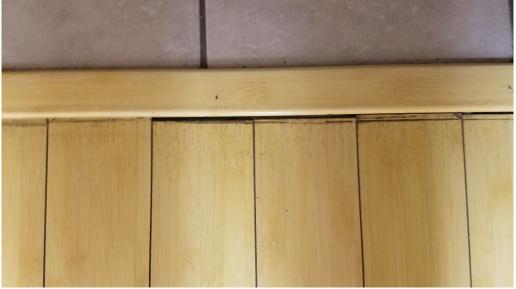
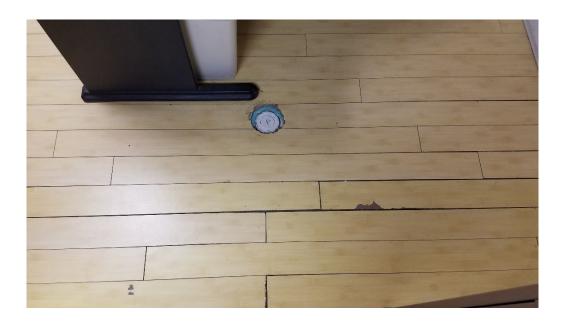
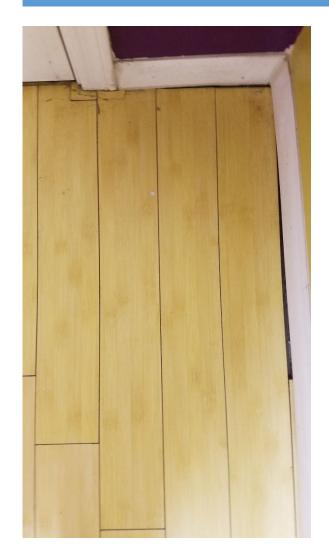
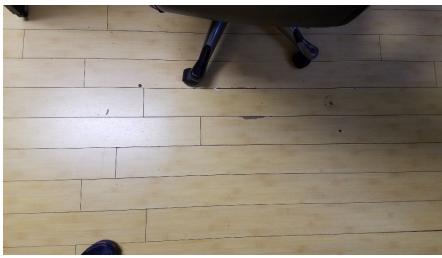
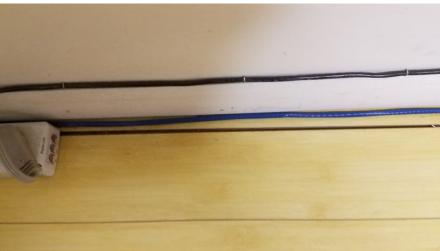
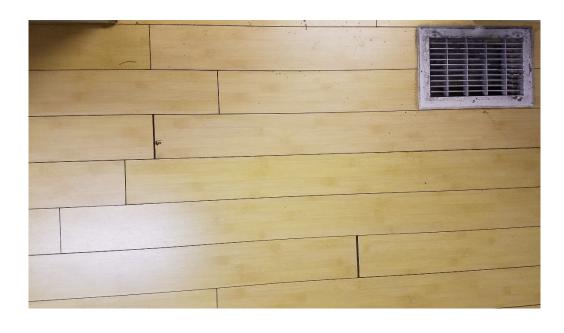
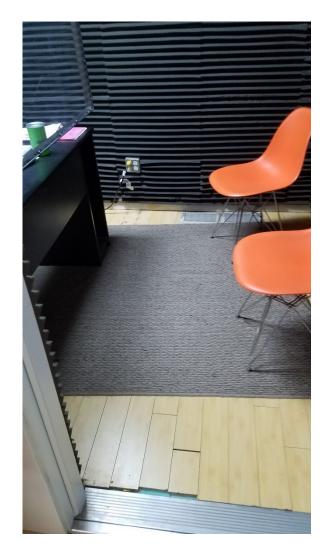
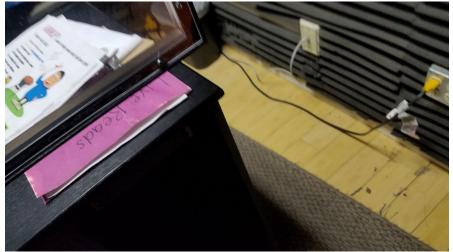
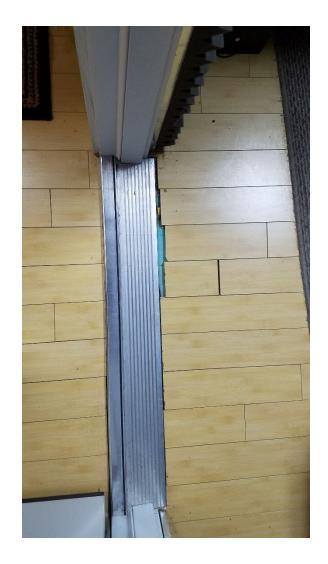
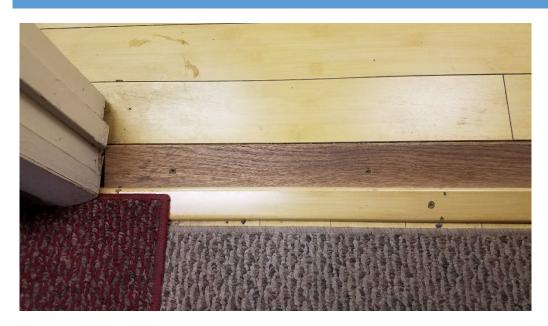
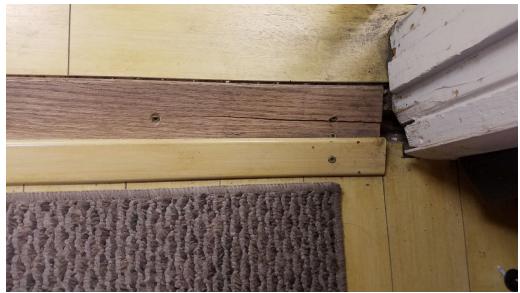
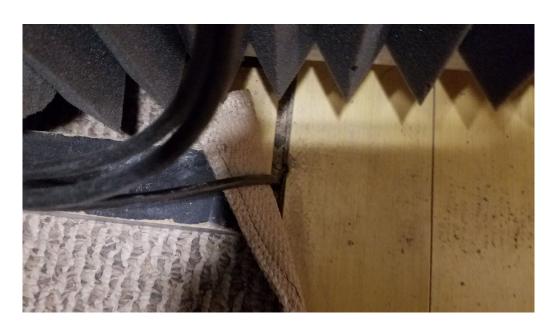
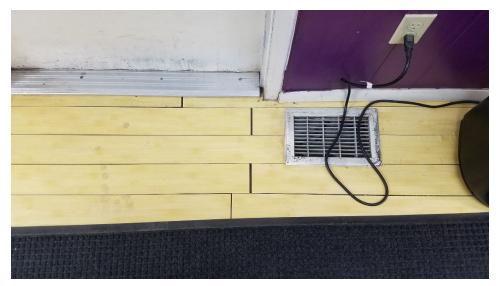
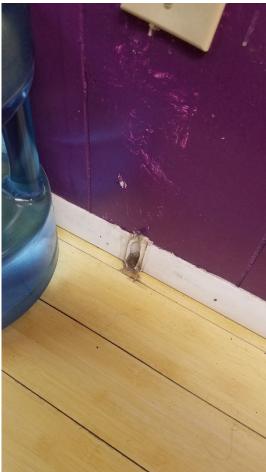
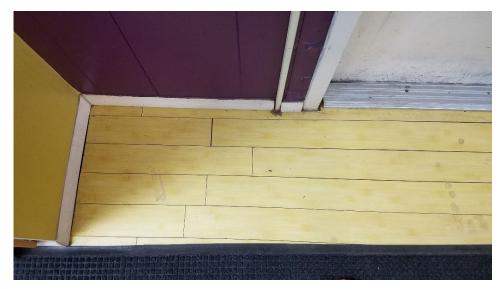
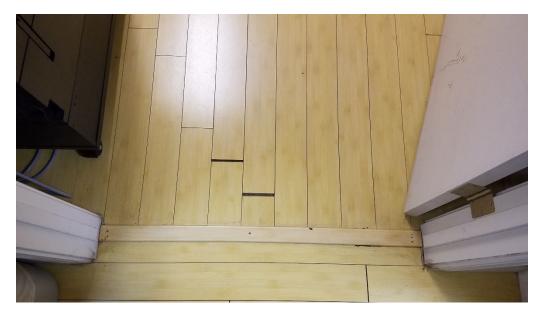
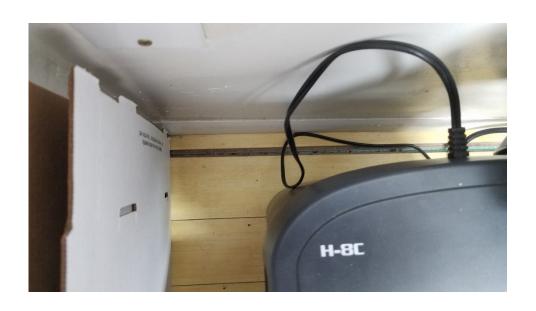
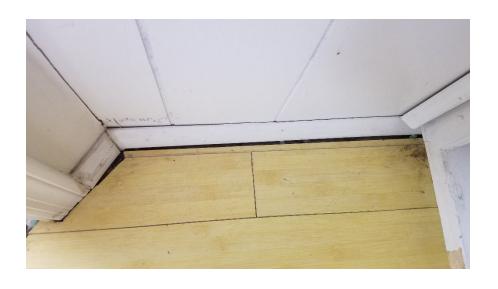
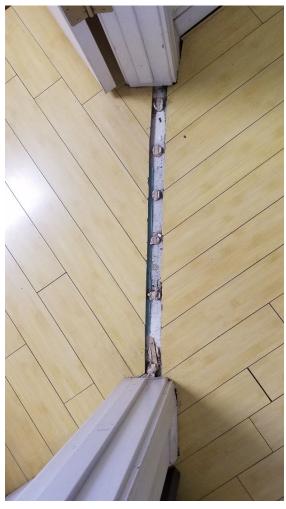
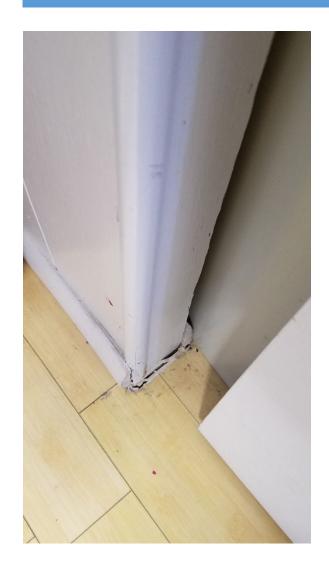
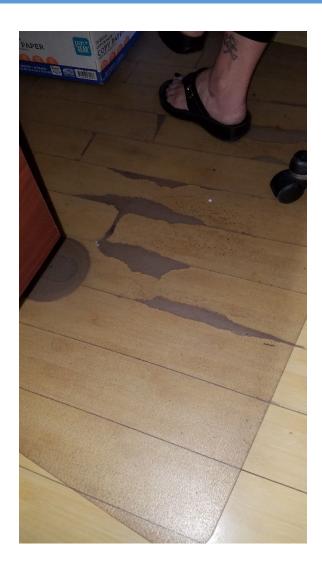
- Planks are- separating, warping, and damaged.
- Some doorways are missing door strips.

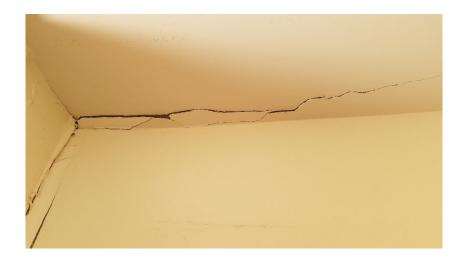
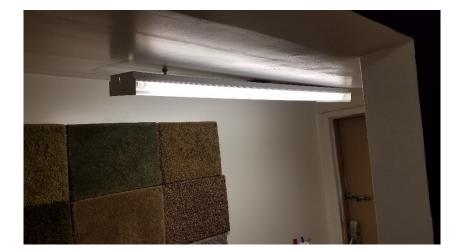
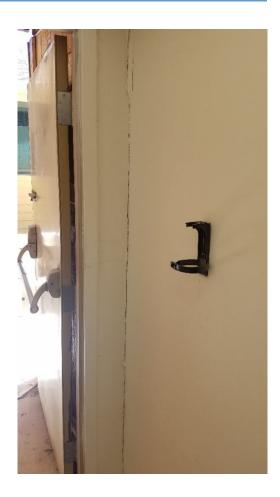
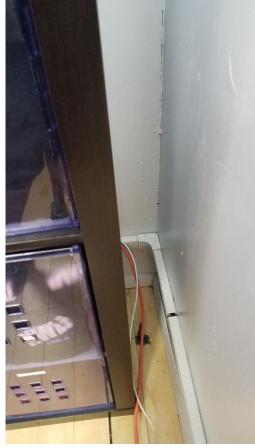
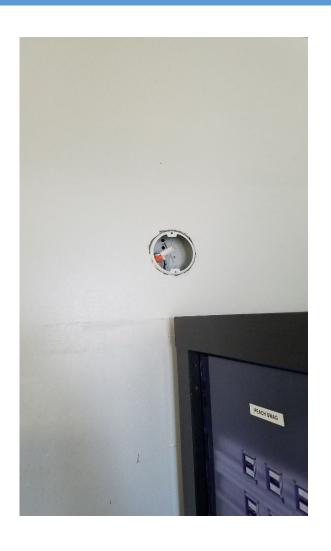
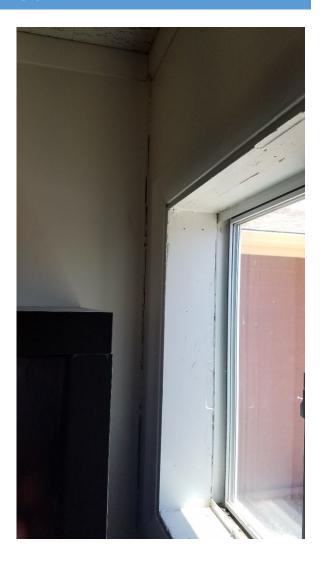
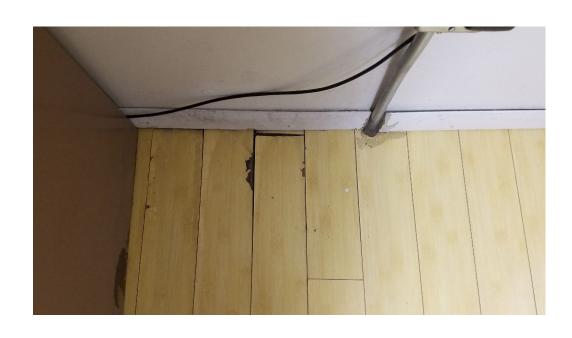
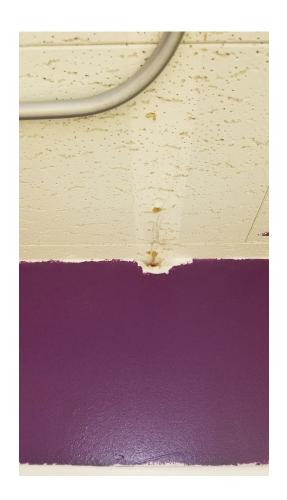
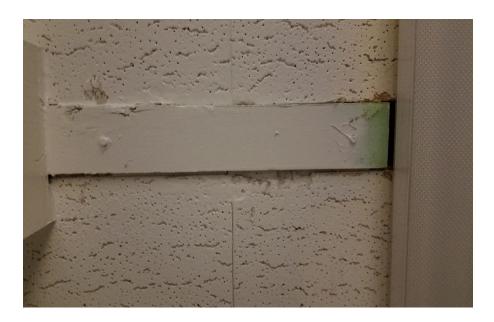
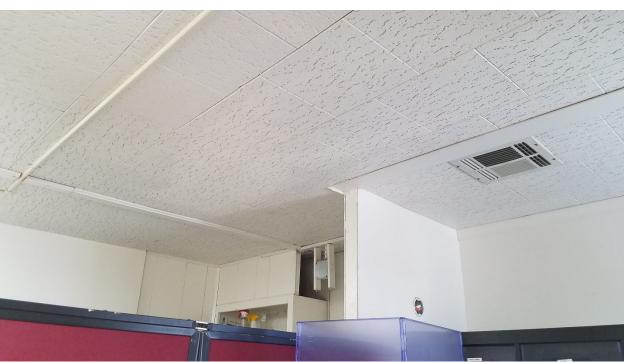
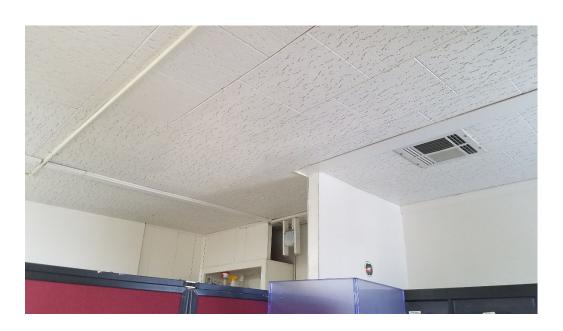
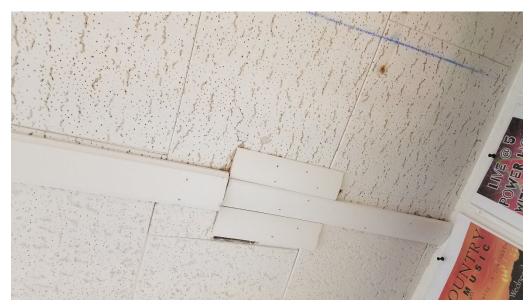
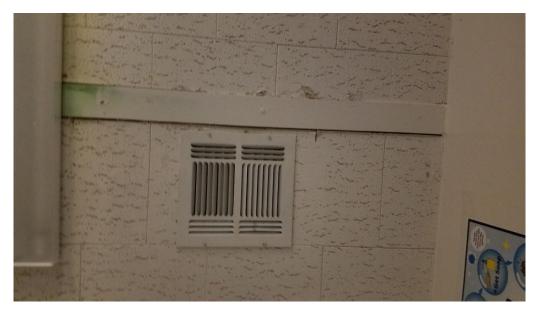
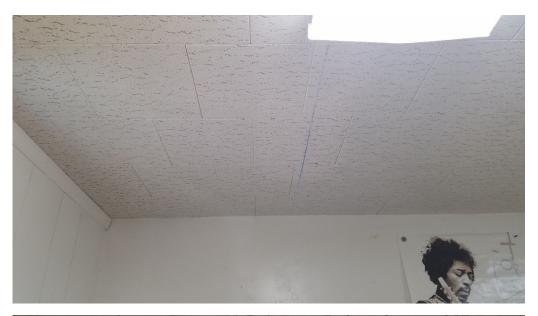
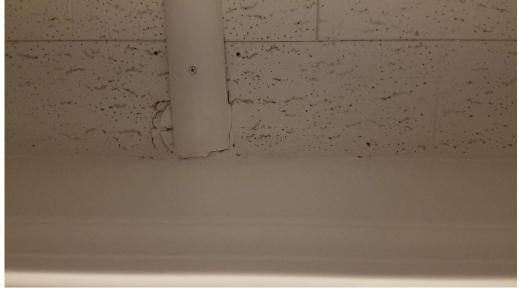
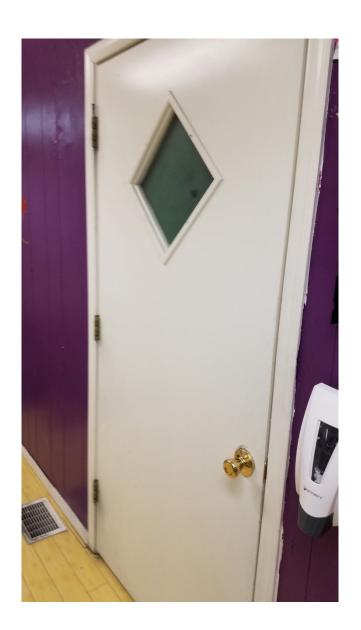
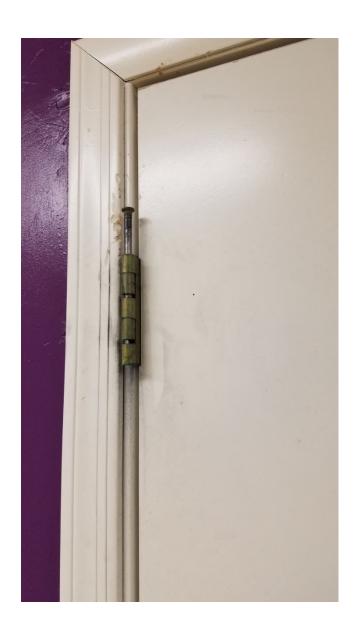
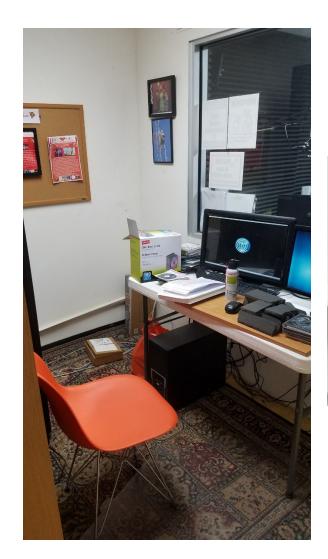
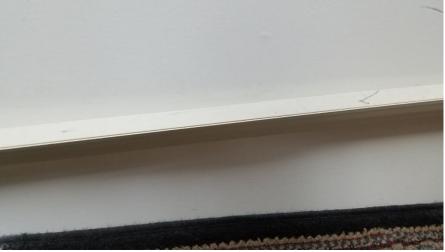
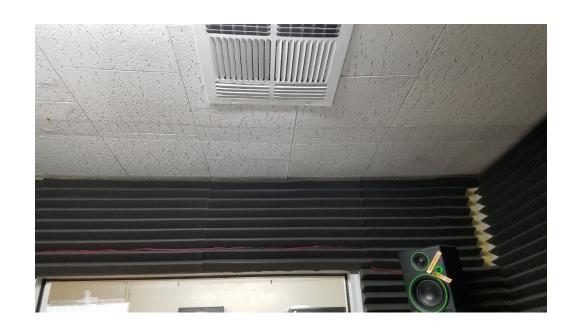
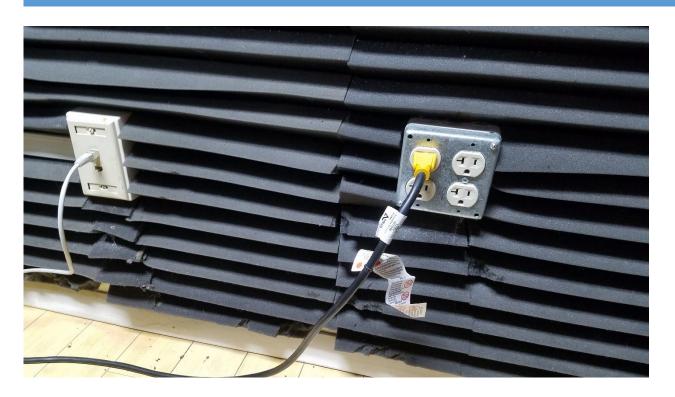
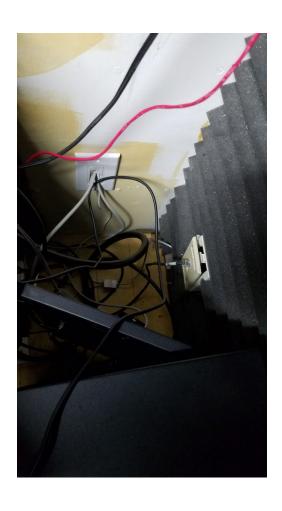
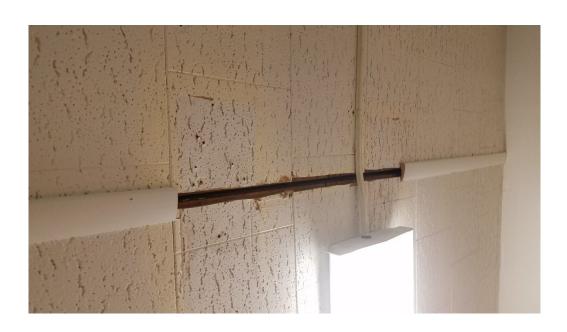
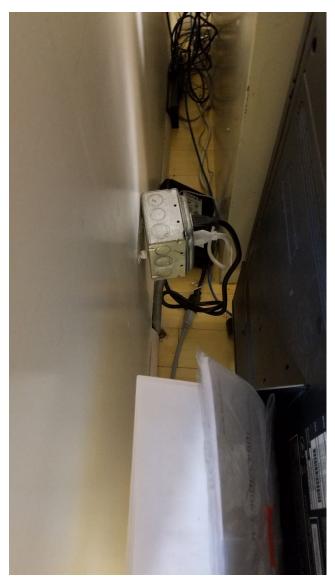
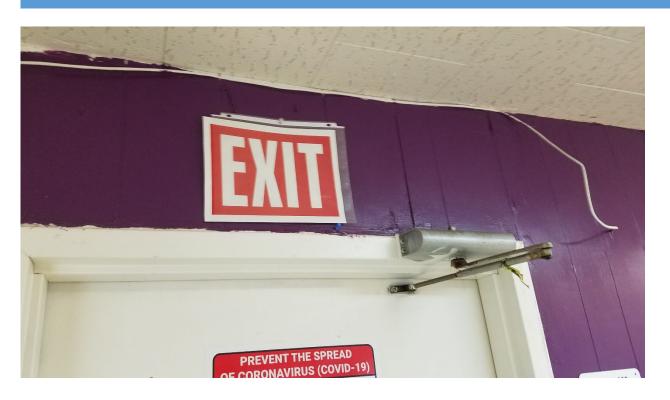
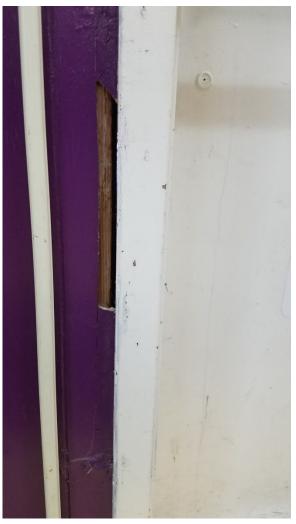
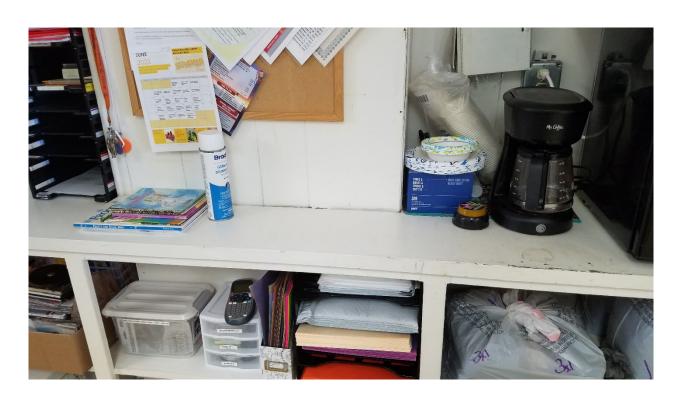
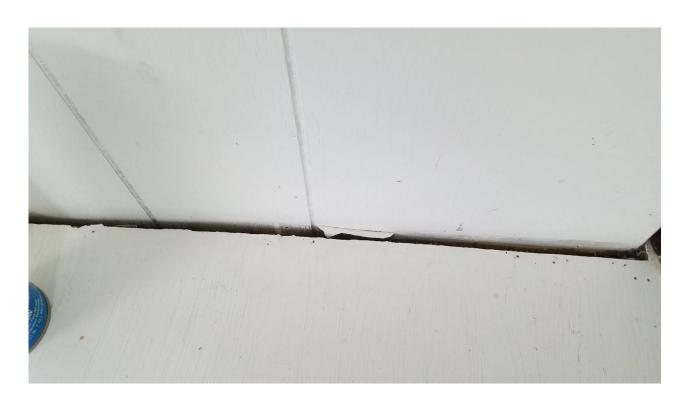
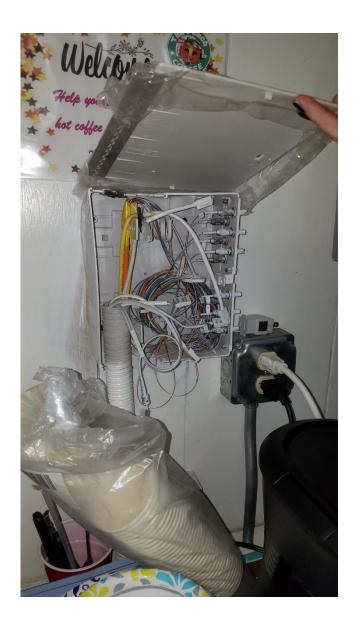
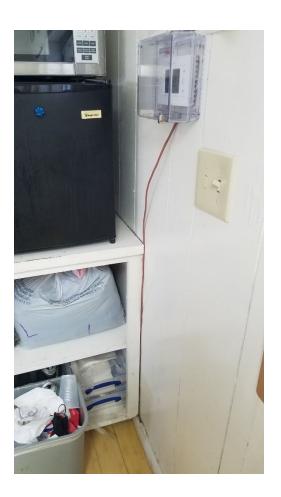
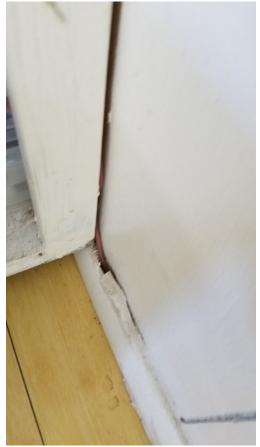
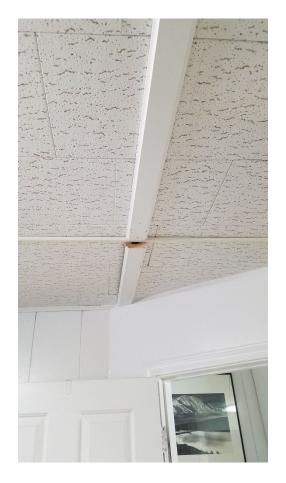
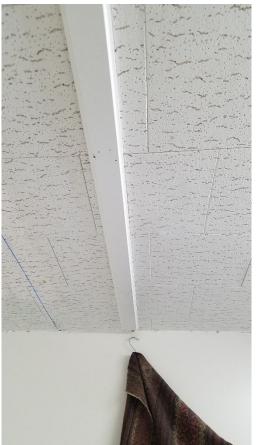
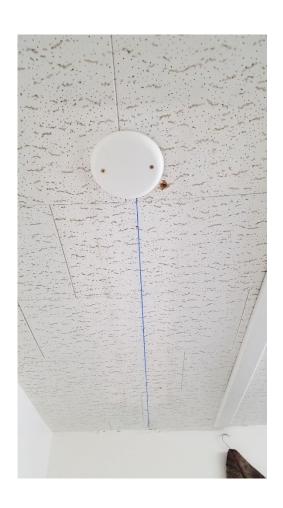
The following images show damage to- ceiling, drywall, interior paneling, and electrical components.
