KWLP "The Peach" Radio Station  
480 B Hualapai Way  
Peach Springs, AZ 86434

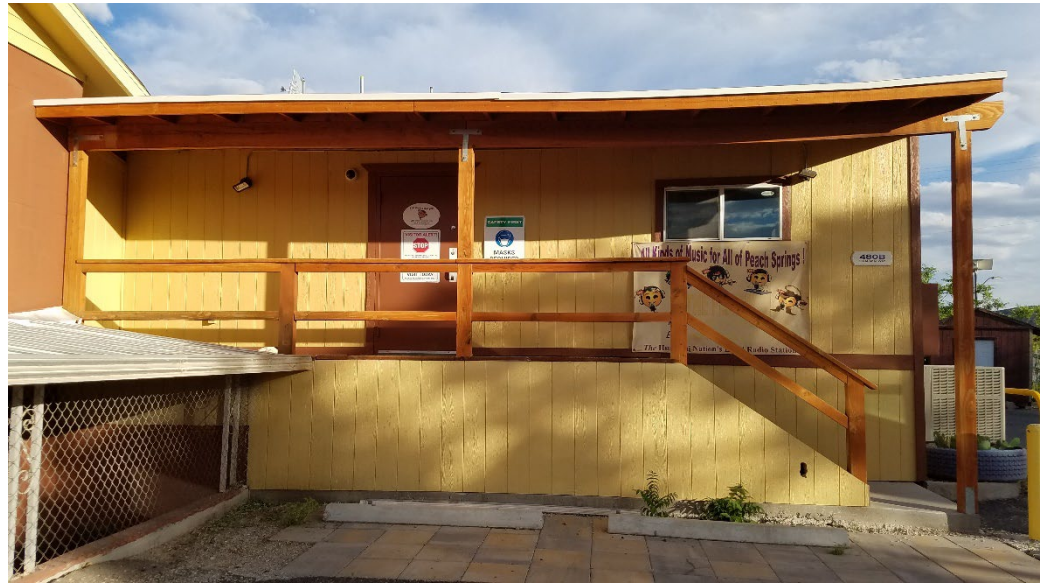
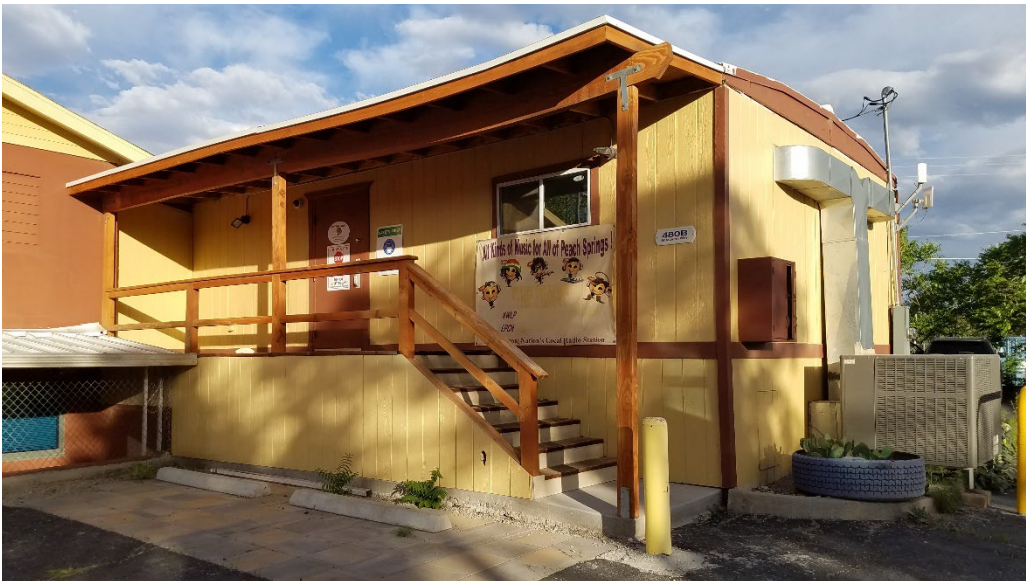
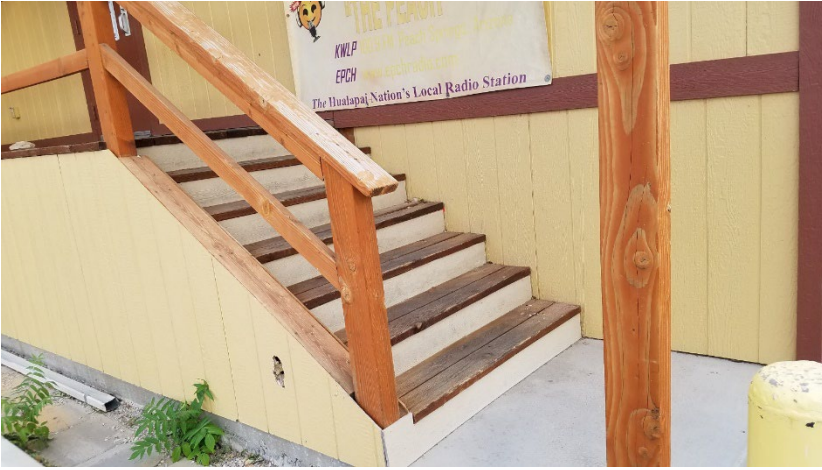
Front exterior view of the Radio station.

Visible damage-

- Awning is sagging.
- Paneling near the staircase is damaged.

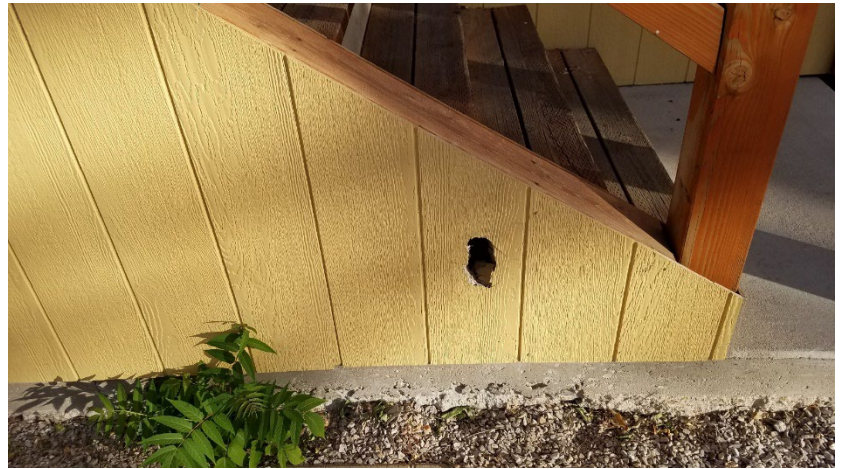
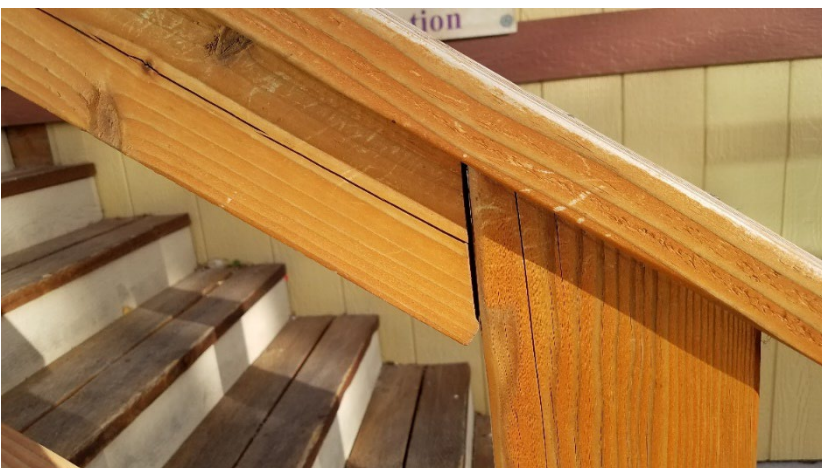
**Steps-**

- Wobbling rail and/or steps.
- Steep slope.

**Paneling damage-**

- Hole is approx. 5" x 3.75"

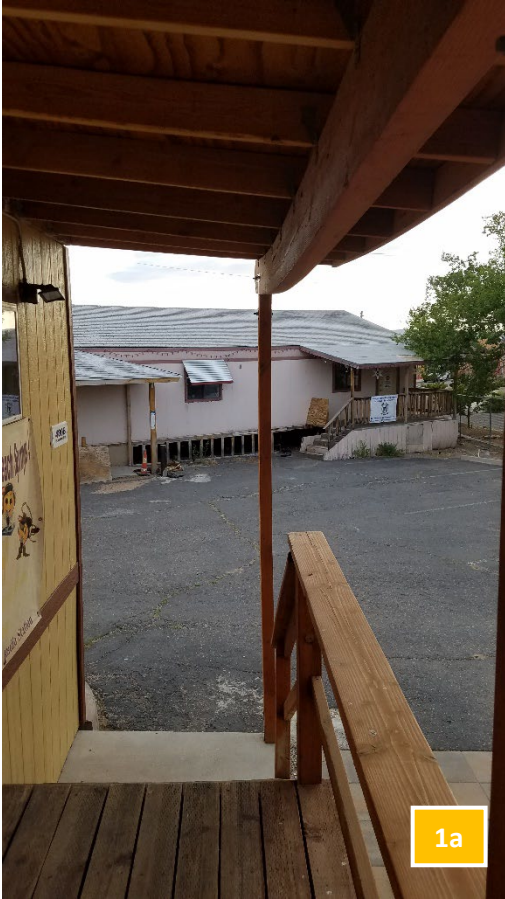
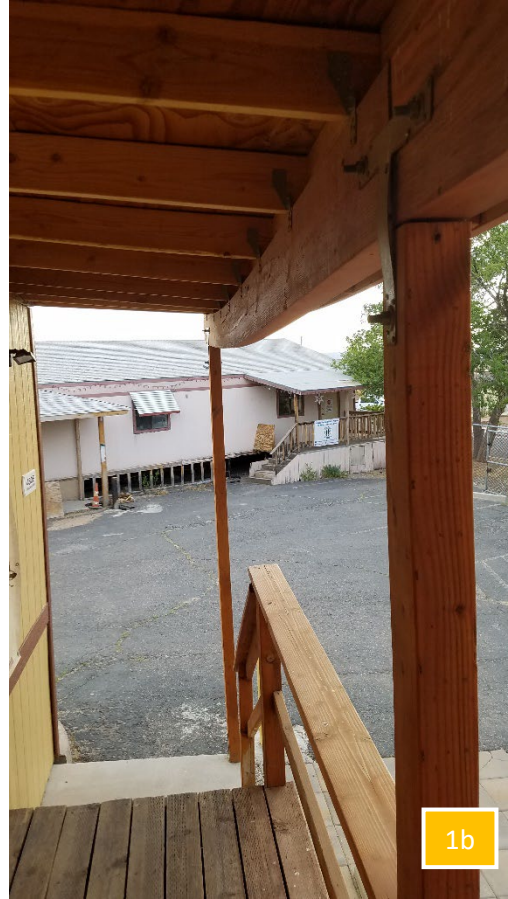
**Hand railing-**

- Separating from top handrail and bottom support.
- Separation is creating wobbling.

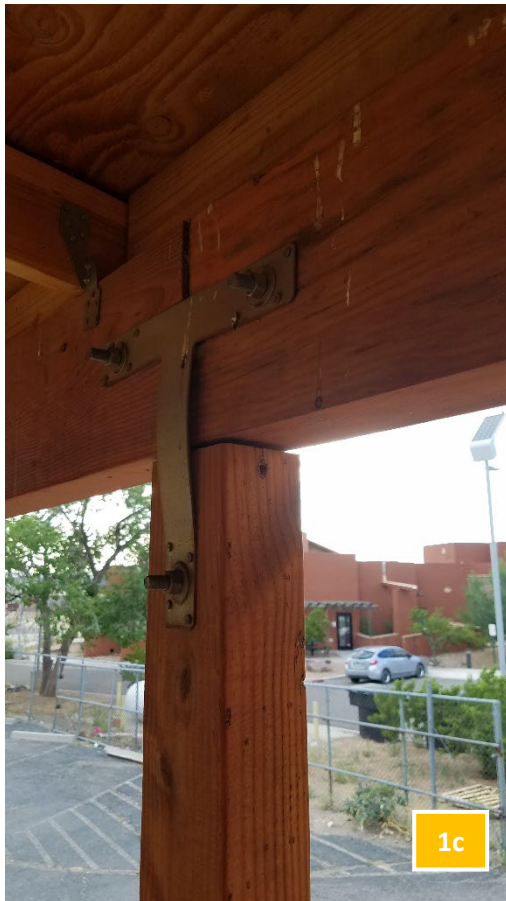
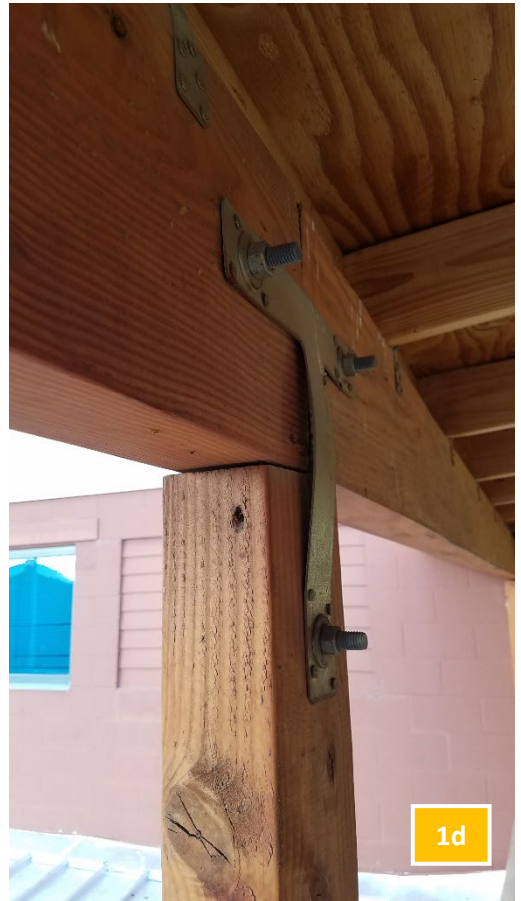
**Awning (1a) & (1b)-**

- Support beam is sagging.

**Awning-**

- (1c) Support beams are separating.
- (1d) Support post is separating from beam.
- Damaged bracket.

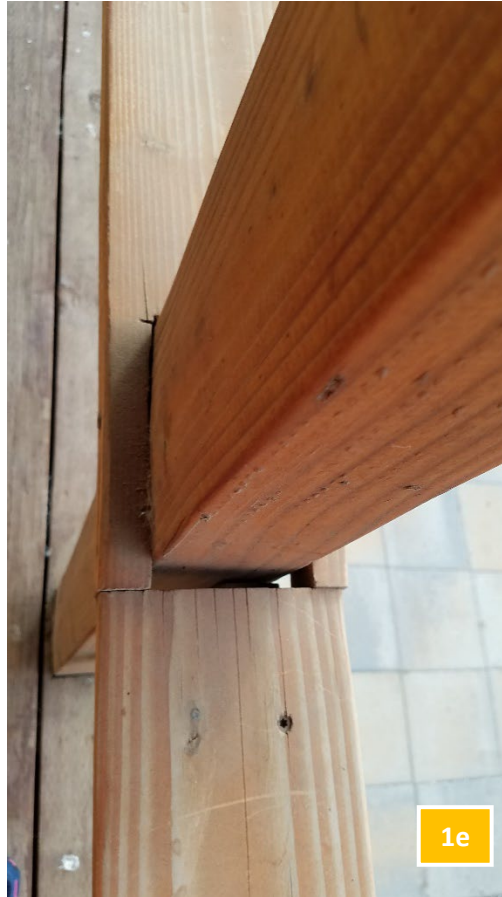
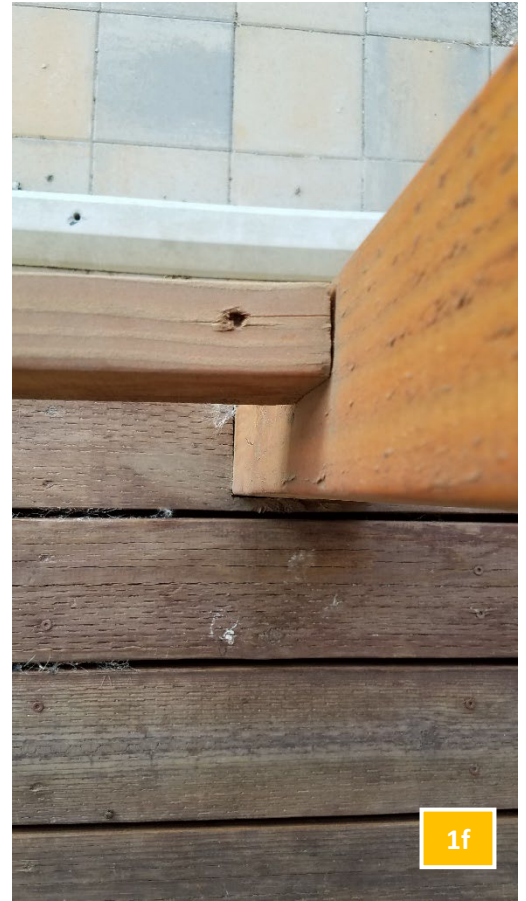
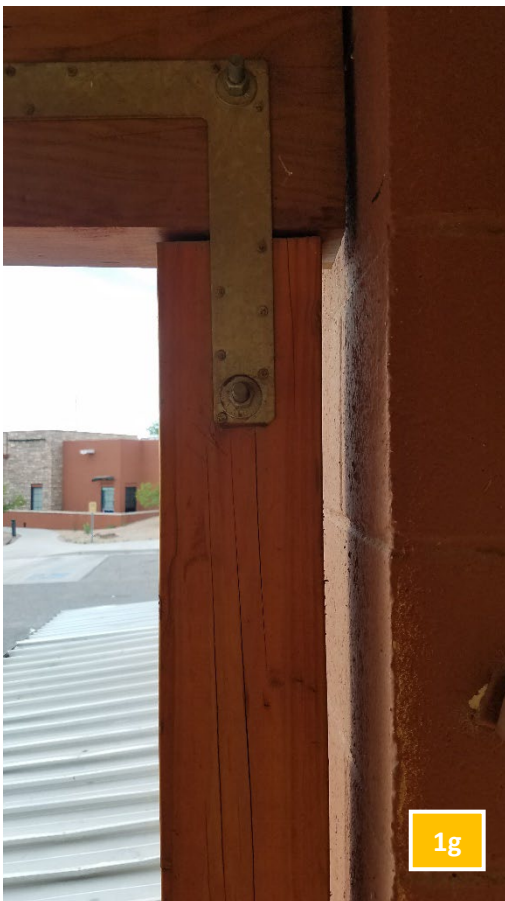
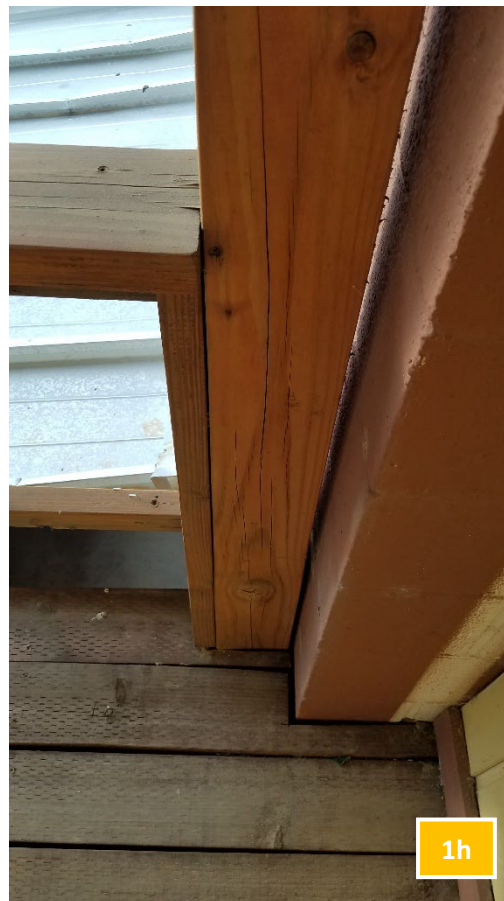
**Support post**  
*(Cont'd from page 3)-*

- (1e) Broken handrailing.
- (1f) Support railing cracked and separating from post.
- Bracket is damaged.

**Support post-**

- (1g) Post is not flush with support beam and wall.
- (1g) Post is not flush.
- (1h) Cracked handrailing.
- (1h) Warped deck.

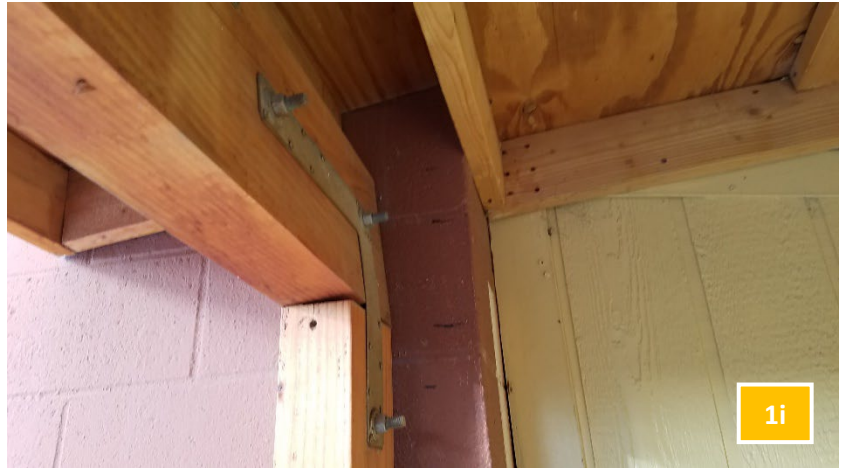
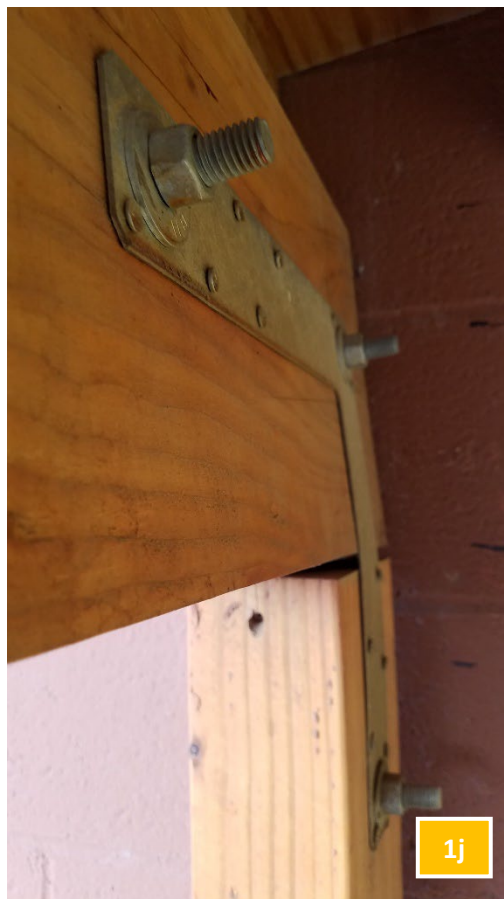
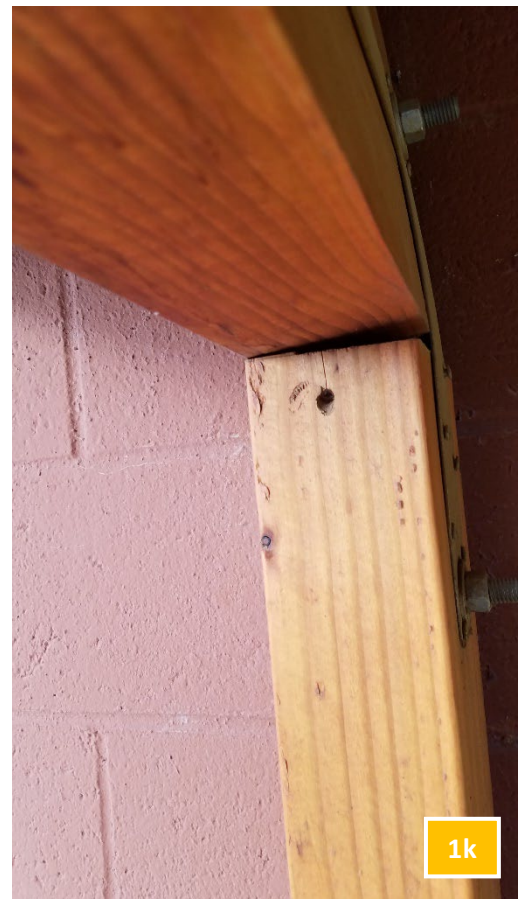
**Support post  
(Cont'd from page 4)-**

- (1i) Post is not flush with support beam.
- (1j) (1k) There is +/- .5" gap between the post and the beam.

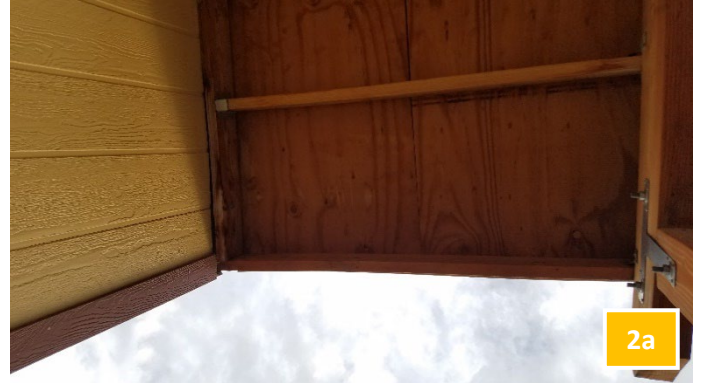
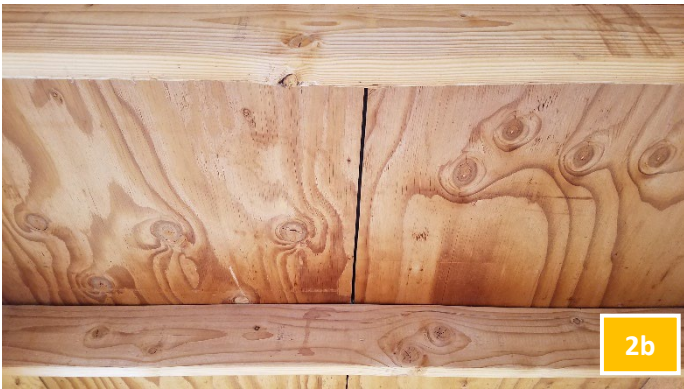
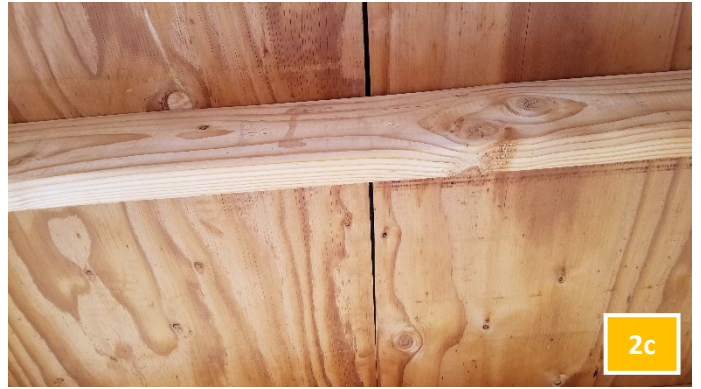
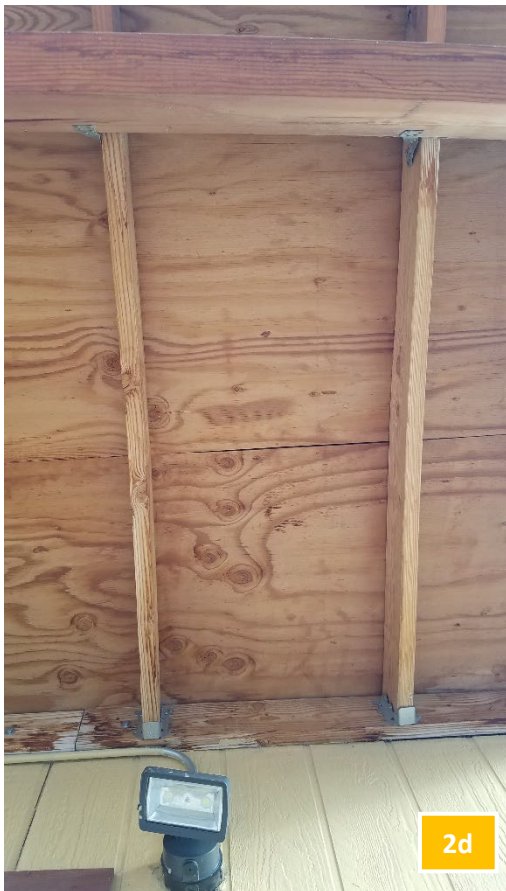
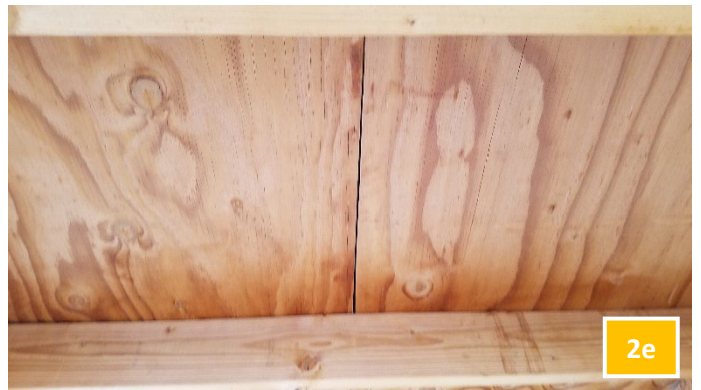
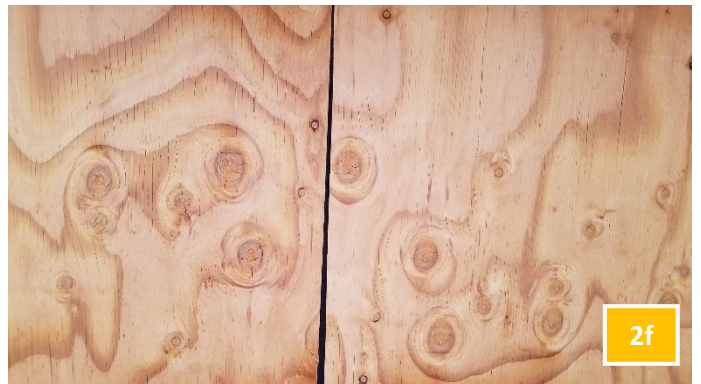
**Awning-**

- (2a) Image of the awning roof starting from the west.
- (2b) through (2c) Plywood is not flush.
- (2d) Weathered.
- (2e) through (2f) Plywood is not flush.

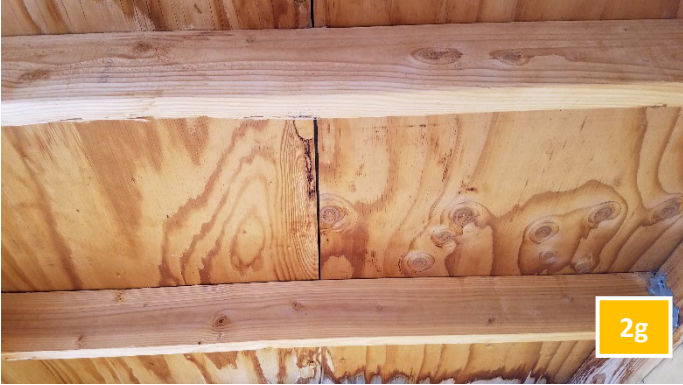
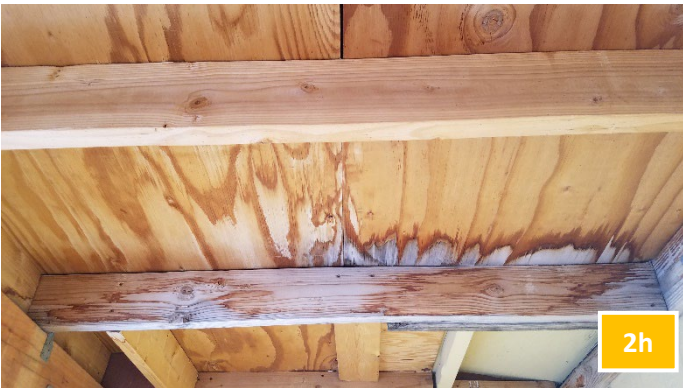
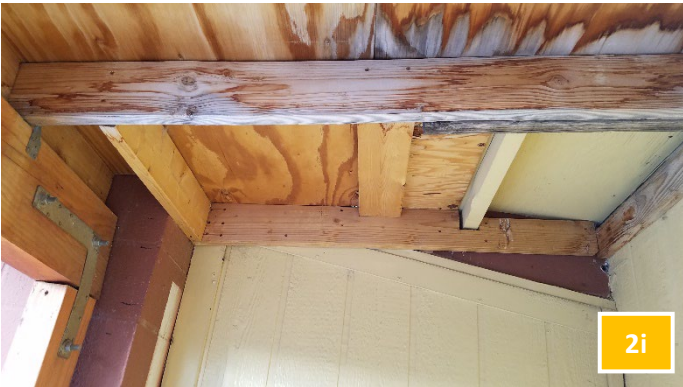
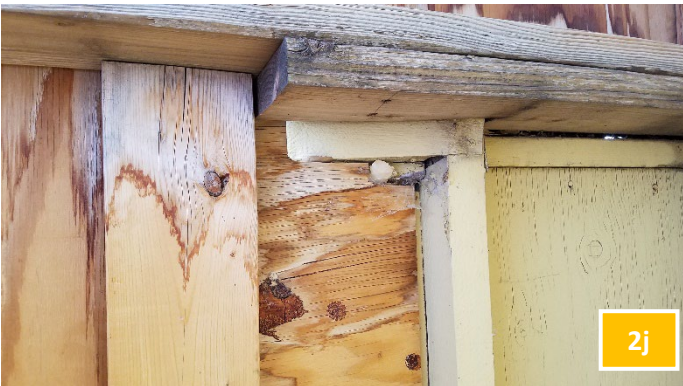
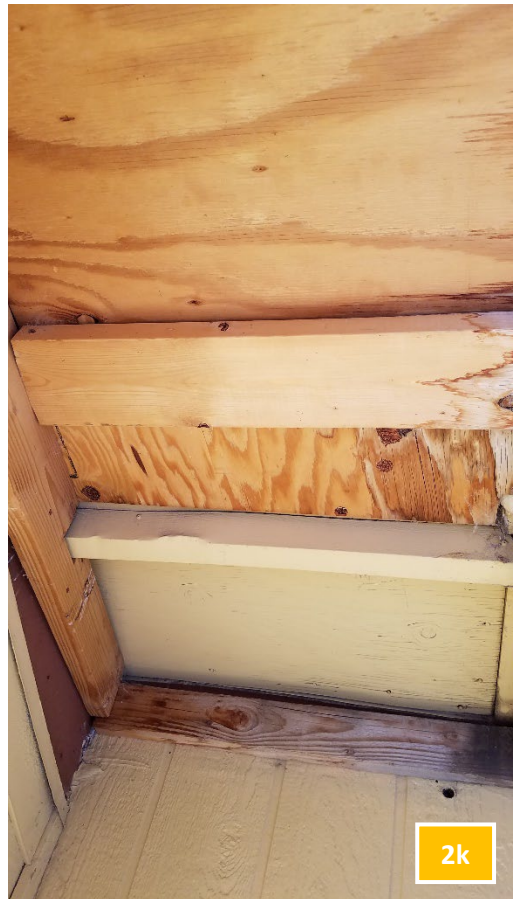
**Awning (Cont'd from pg. 7)-**

- (2g) Plywood is not flush.
- (2h) through (2k) water damage.

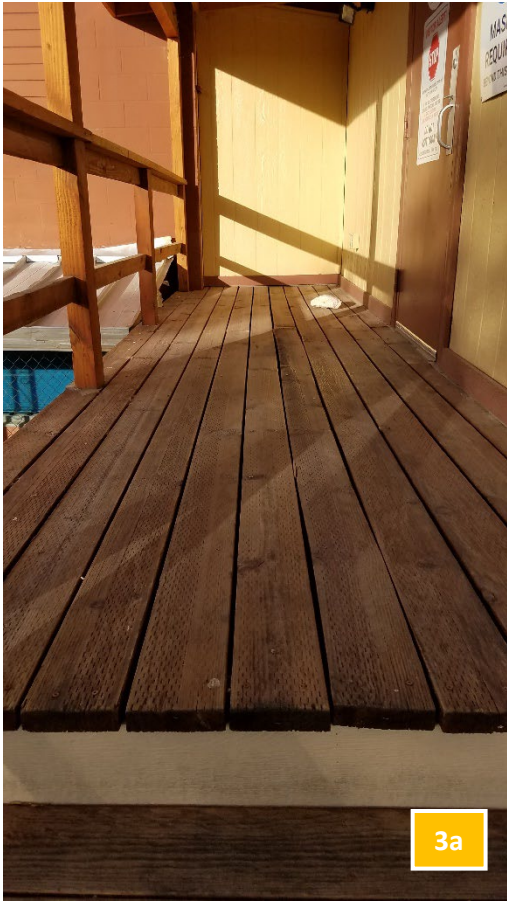
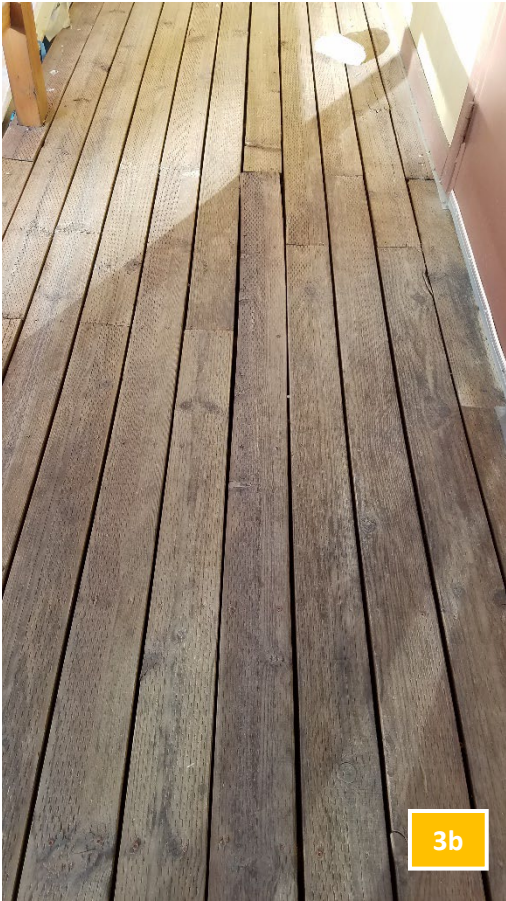
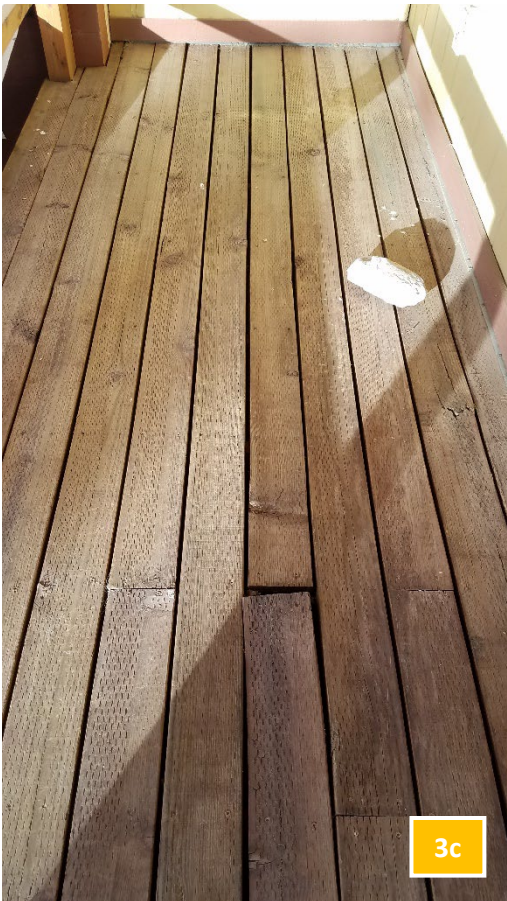
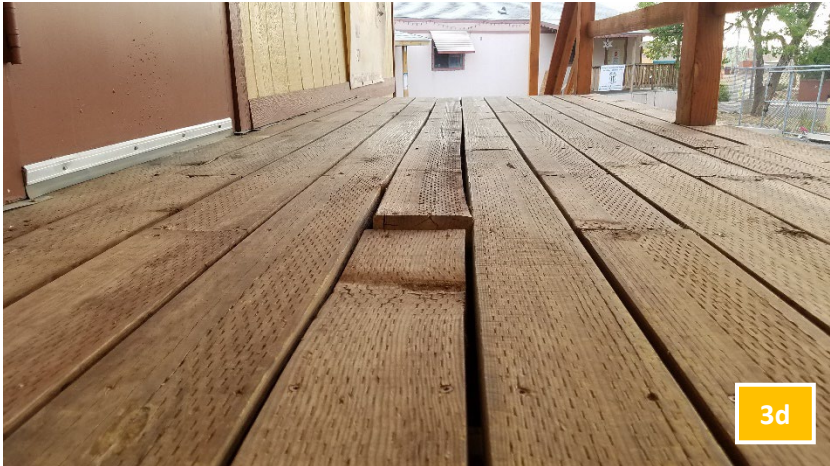
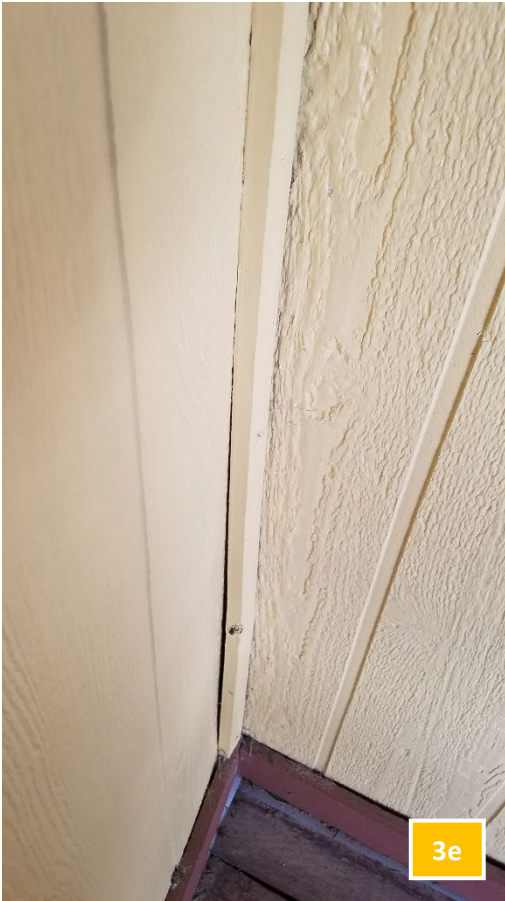
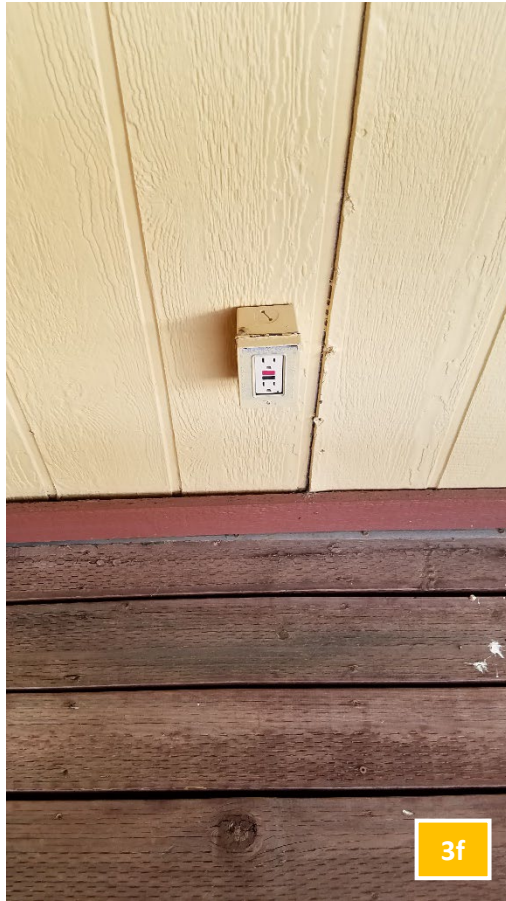
Deck-

- (3a) (3b) Deck is warn, warped, sagging, and plank/s are lifting.
- (3c) (3d) Plank lifting.

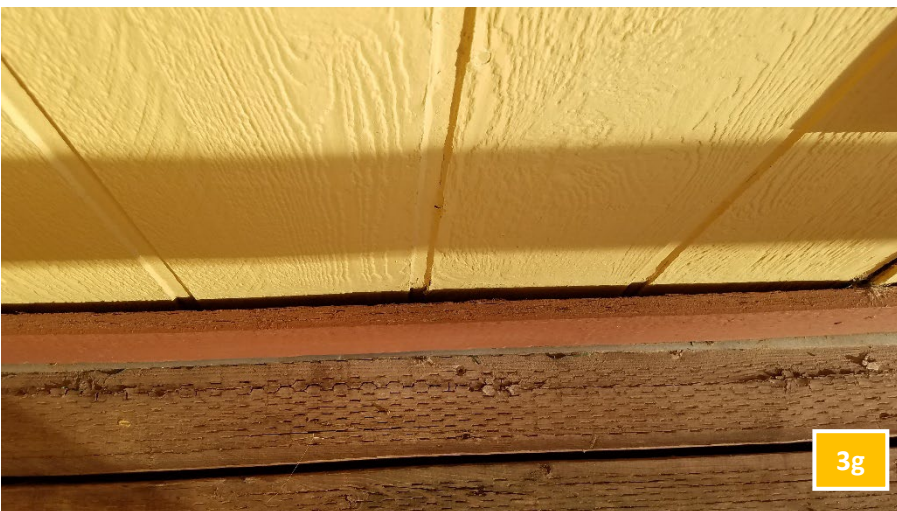
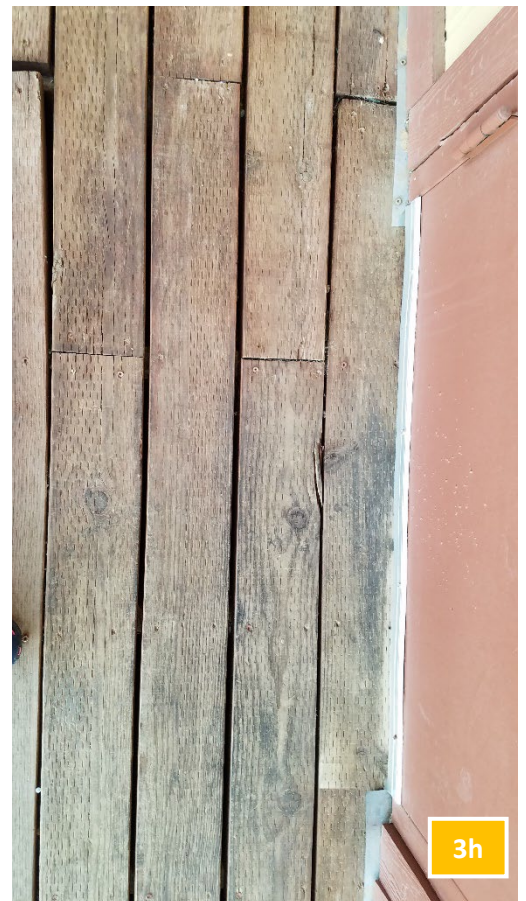
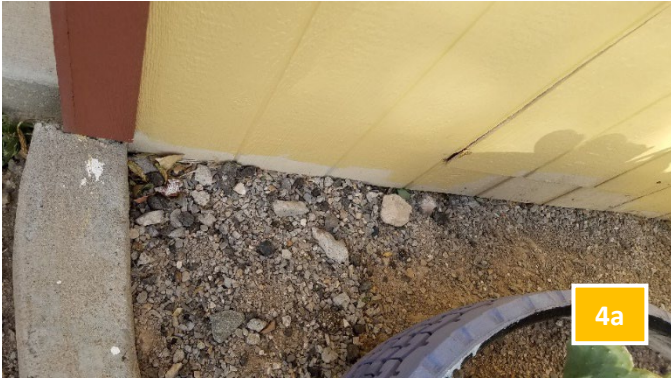
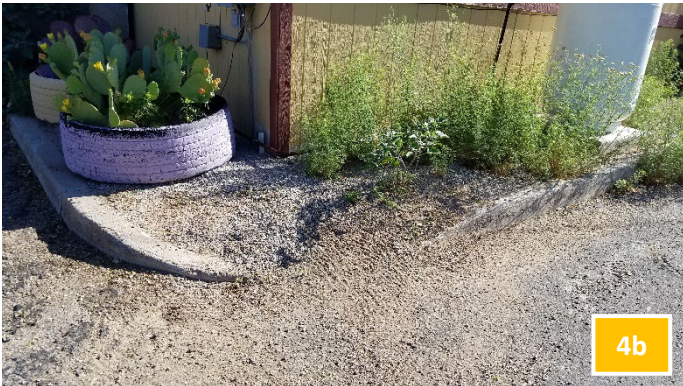
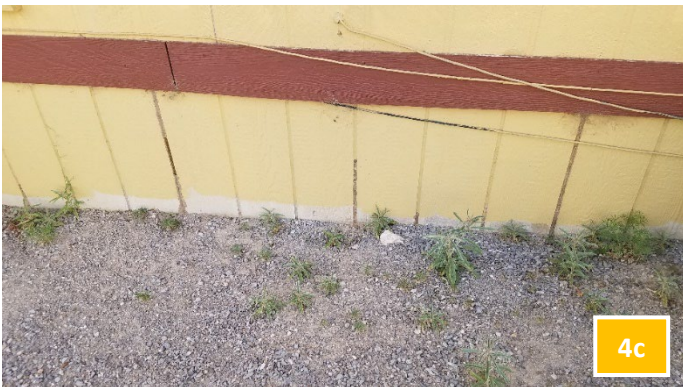
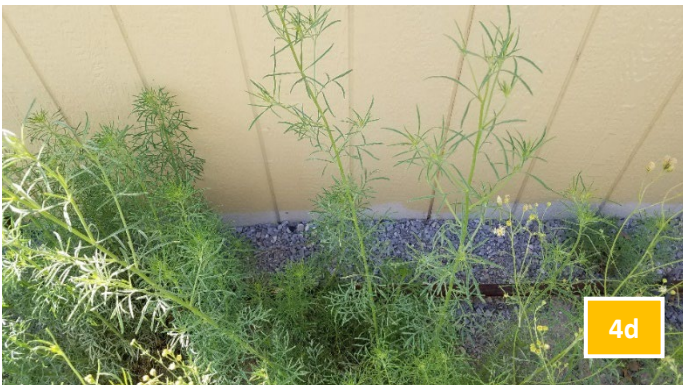
**Deck**  
**(Cont'd from pg. 9)-**

- (3e) Trim pulling away due to water damage (see (2h) through (2K) on pg. 7)
- (3f) Need to replace outlet.
- (3g) Trim damaged.
- (3h) Planks lifting

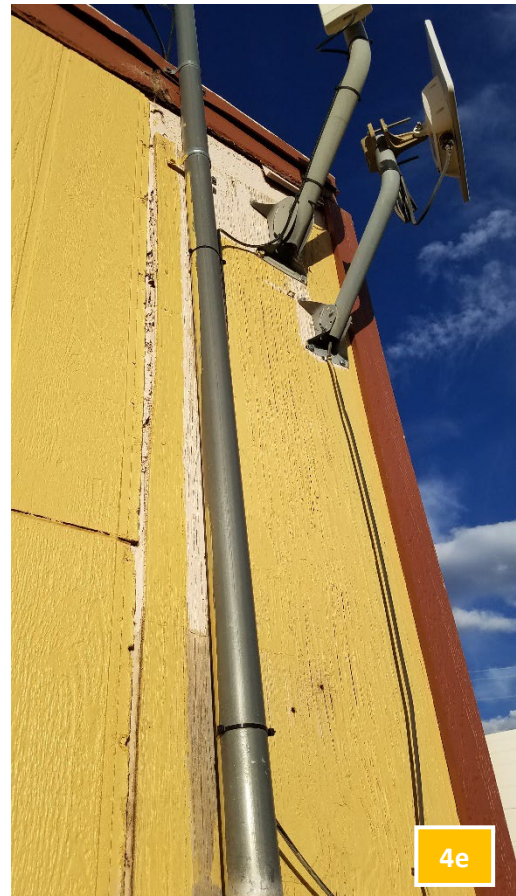
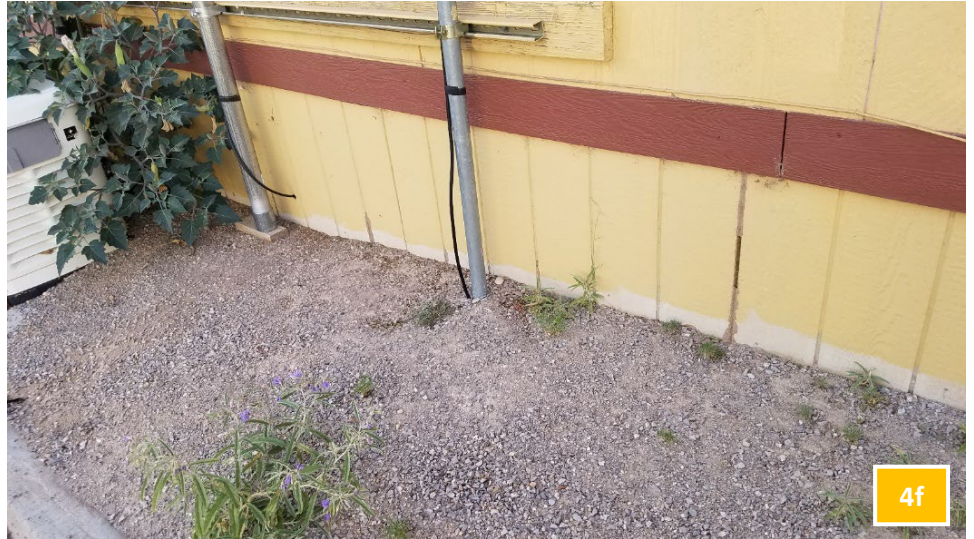
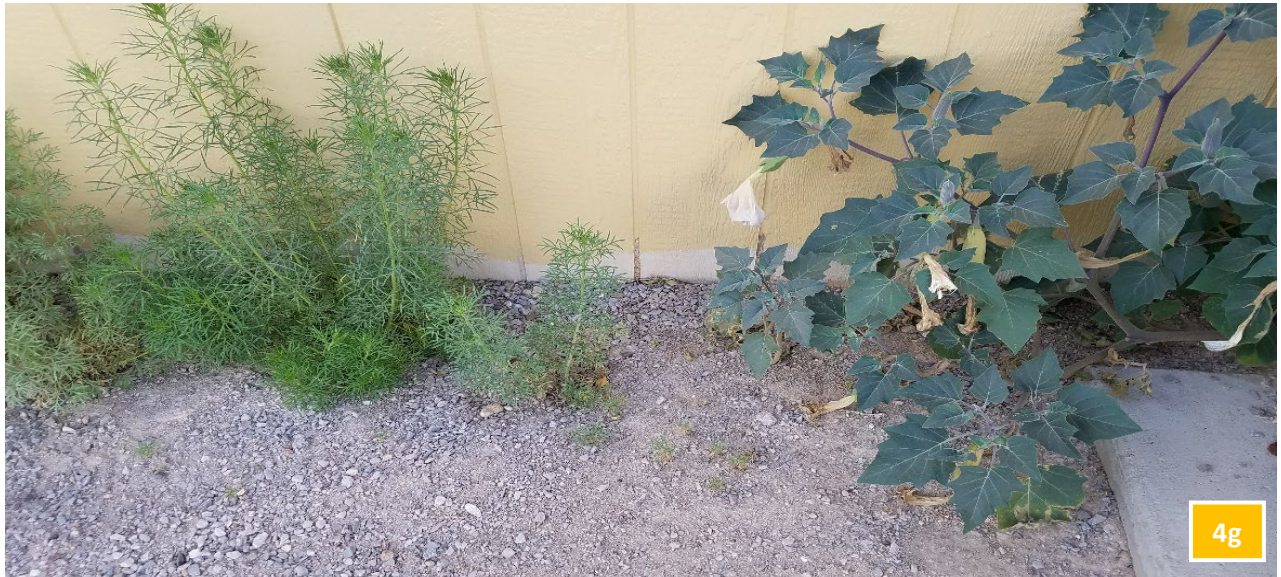
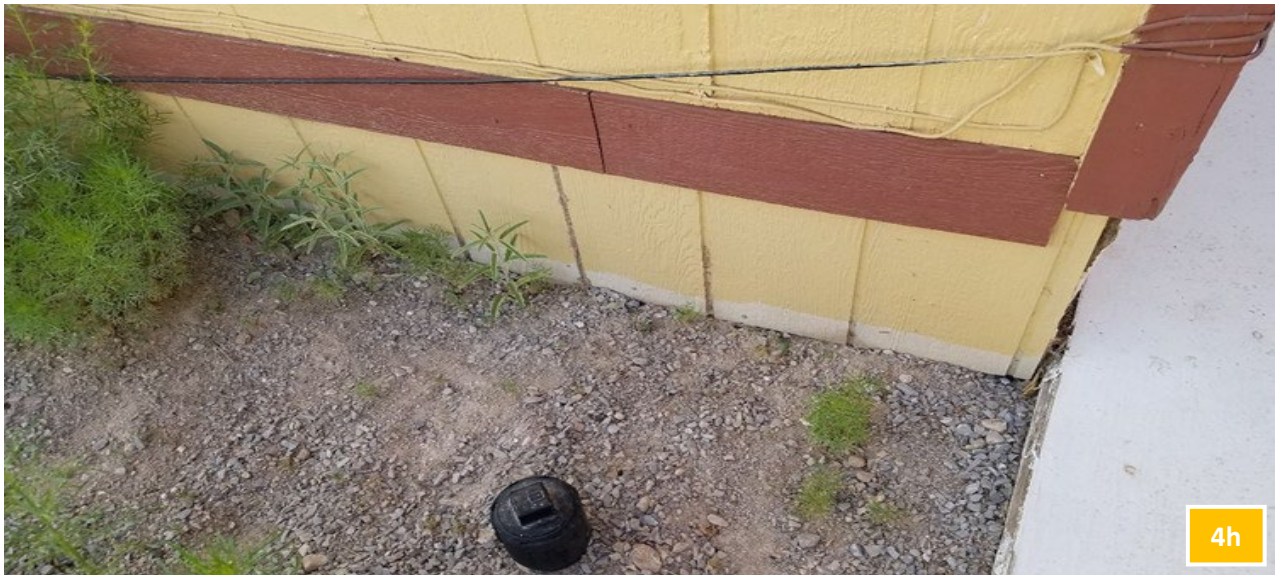
**Skirting- left unpainted.**

- (4a) (4b) (4c) (4d) Images of the west side of the radio station. Landscaping and chat needed.
- (4b) Concrete barrier needs to be repaired.
- (4b) (4c) Paneling damaged and needs to be painted.
- (4e) Image of back of the radio station from the west.
  - Paneling damaged. Needs to be repaired or repainted.

Skirting- left unpainted  
(Cont'd from pg. 11)-

- (4f) through (4h) Images back of the radio station. West to East.
- Landscaping and chat needed.

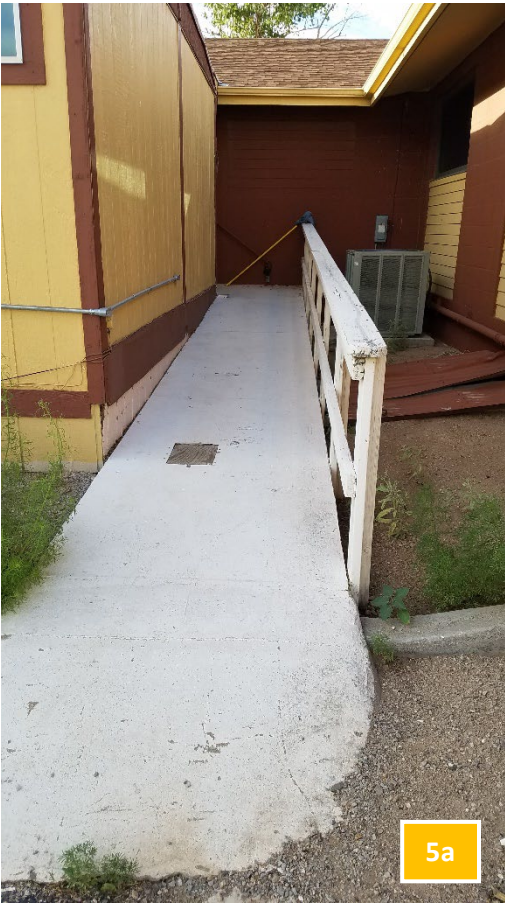
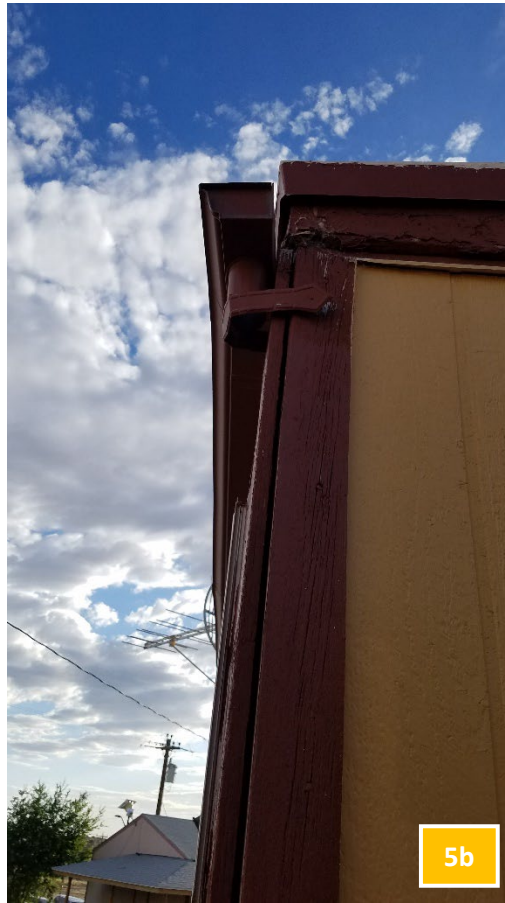
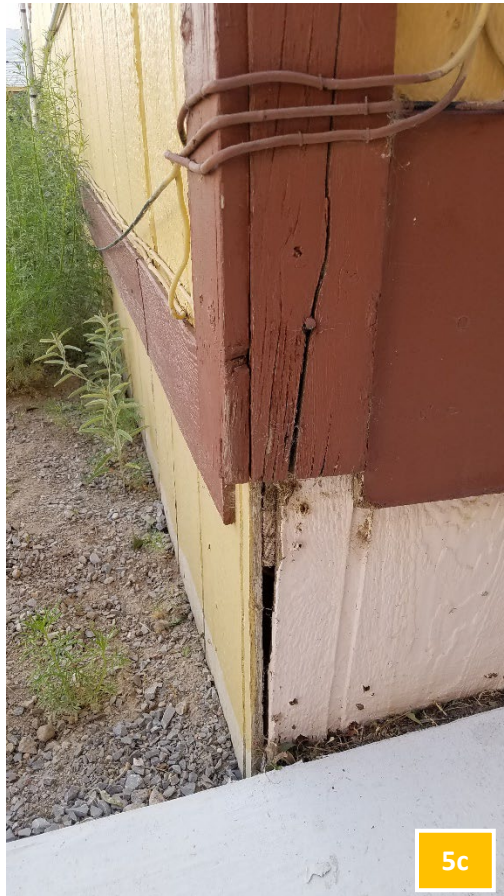
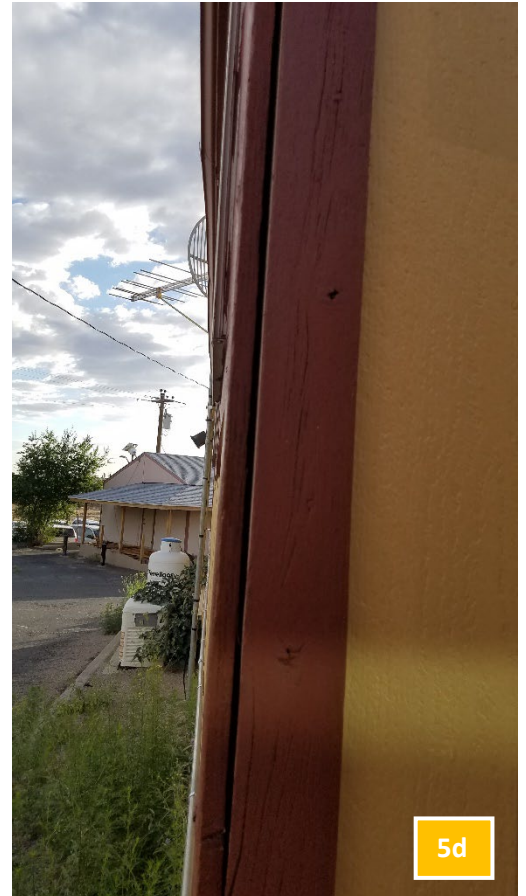
**Rear entrance-**

- (5a) Hand rail is wobbly. It needs to be repaired and painted.
- (5b) Gutter needs to be reinforced.
- (5b) (5c) (5d) Images of trimming. Needs to be repaired or replaced.

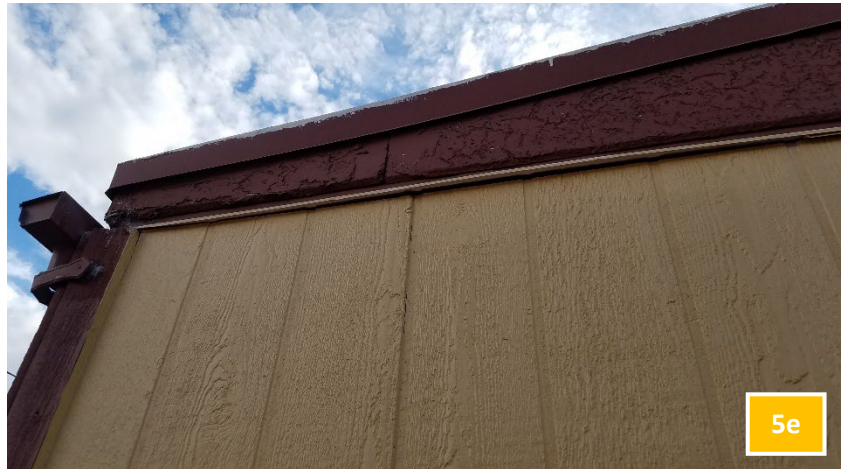
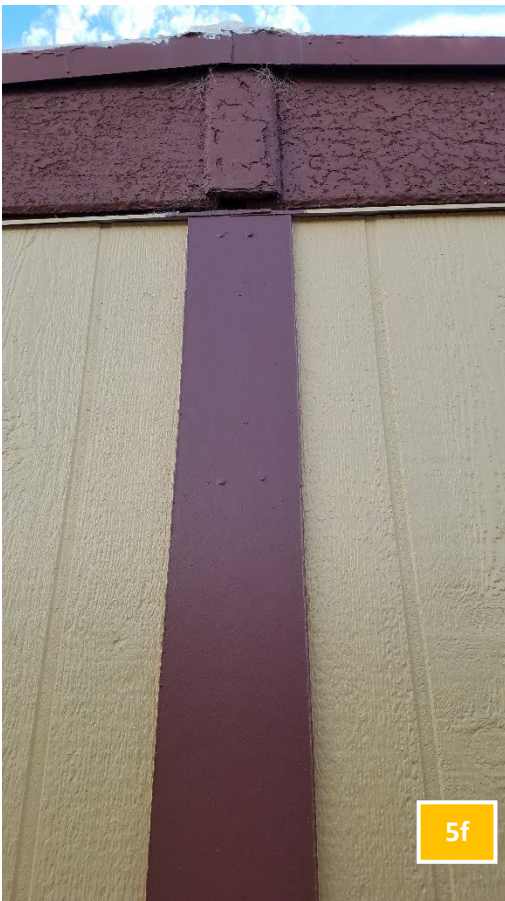
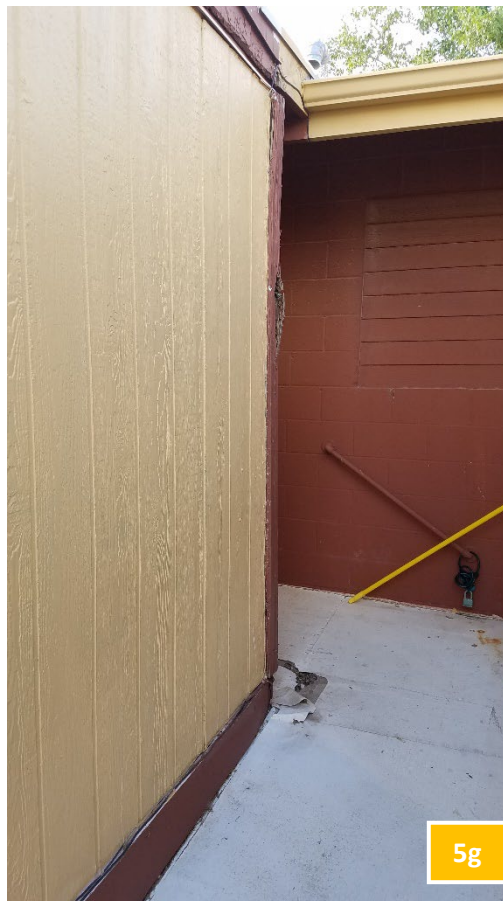
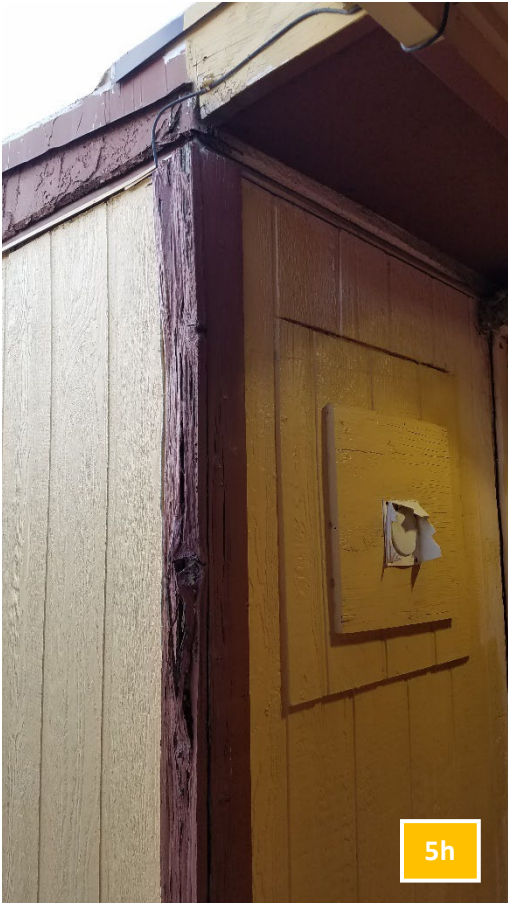
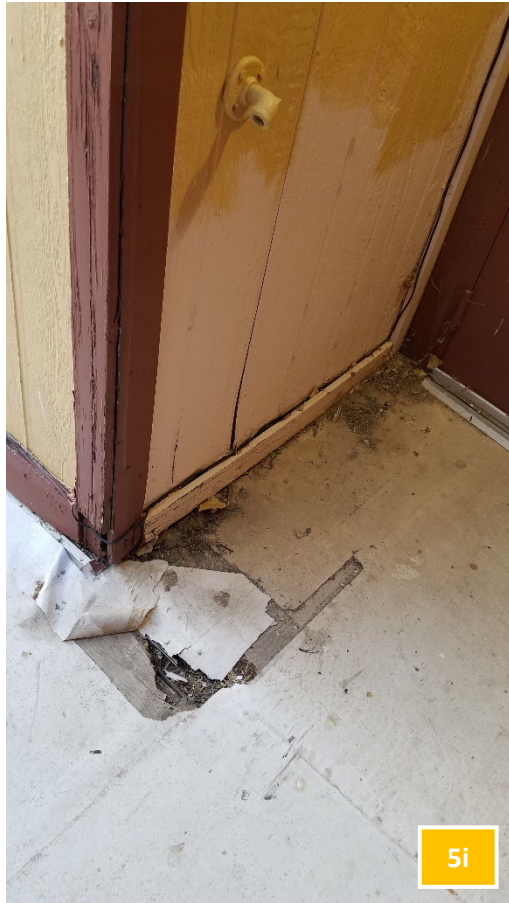
Rear entrance-  
(Cont'd from pg. 13)

- (5e) (5f) (5g) Trim needs to be reinforced or replaced and painted.
- (5g) floor needs to be repaired.
