KWLP "The Peach" Radio Station  
480 B Hualapai Way  
Peach Springs, AZ 86434

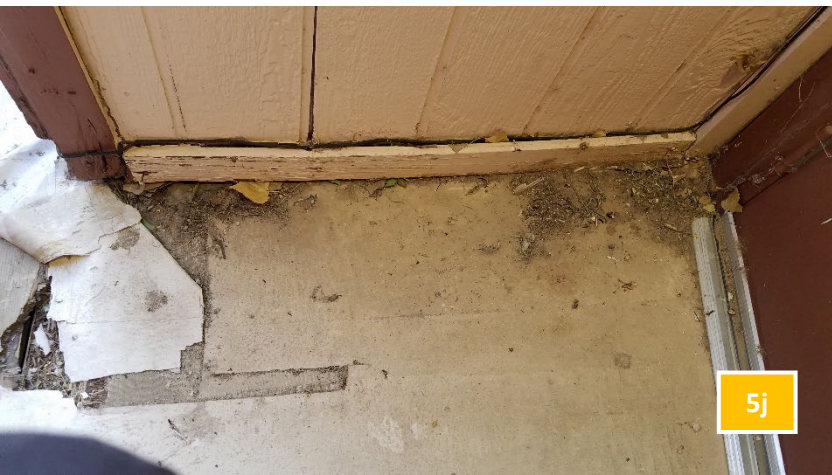
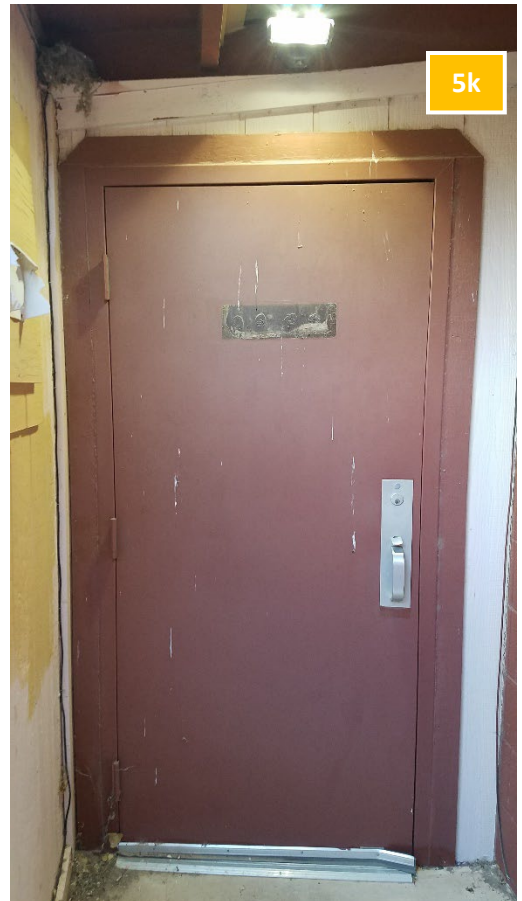
**Rear entrance-  
(Cont'd from pg. 14)**

- (5h) Trim needs to be replaced.
- (5i) (5J) Flooring and trim needs to be repaired.
- (5K) Trim for exit door needs to be repaired.
